**Affordable Home Inspection Inc.**

**0519-3534**

**Martine Haddad**

**3233 Bishop Pine St  
Las Vegas, NV 89129**

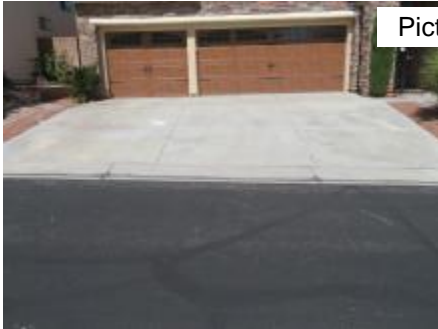
Picture 1

The driveway appeared to be in serviceable condition at the time of the inspection.

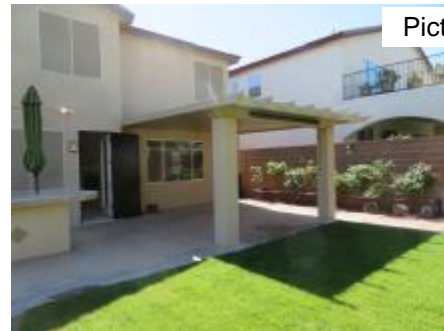
Picture 4

The alumna wood patio cover appeared to be in serviceable condition at the time of the inspection.

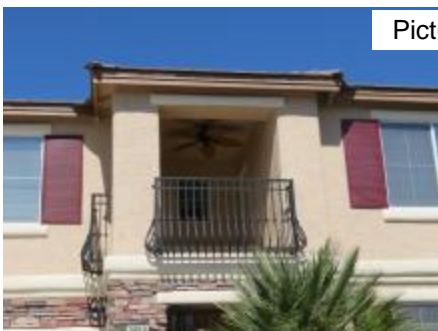
Picture 5

The front balcony appeared to be in serviceable condition at the time of the inspection.

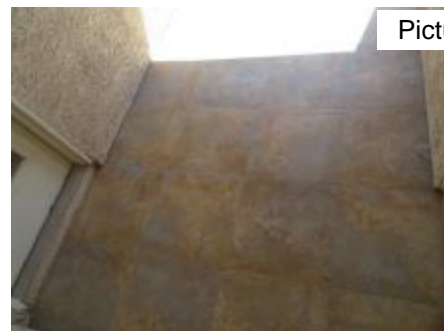
Picture 6

The front balcony deck tiled surface appeared to be in serviceable condition at the time of the inspection.

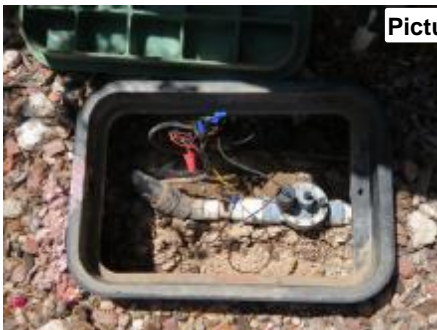
Picture 9

The front zone is shut off due to a leak under the palm tree.

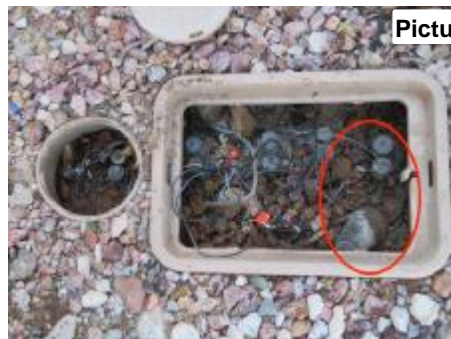
Picture 11

Zone valve for the back drip system does not operate.

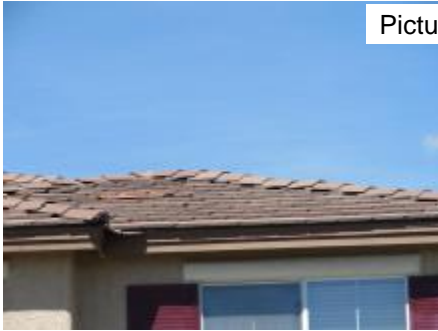
Picture 19

The main roof covering and exposed flashing appears to be in serviceable condition.

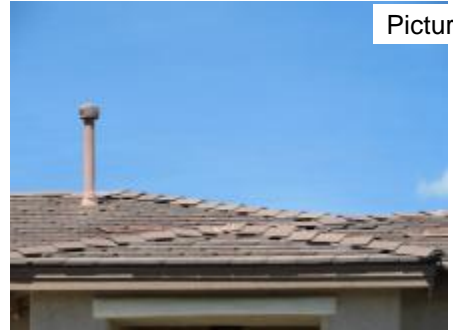
Picture 20

The main roof covering and exposed flashing appears to be in serviceable condition.

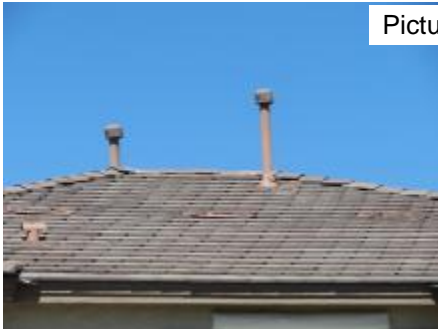
Picture 21

The main roof covering and exposed flashing appears to be in serviceable condition.

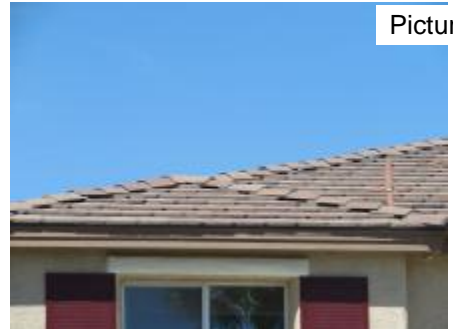
Picture 22

The main roof covering and exposed flashing appears to be in serviceable condition.

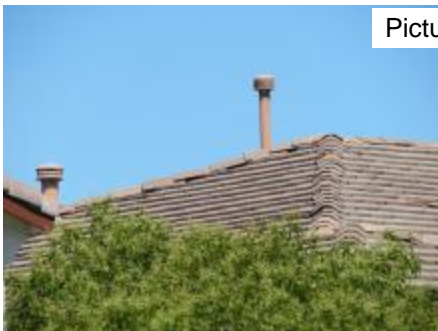
Picture 23

The main roof covering and exposed flashing appears to be in serviceable condition.

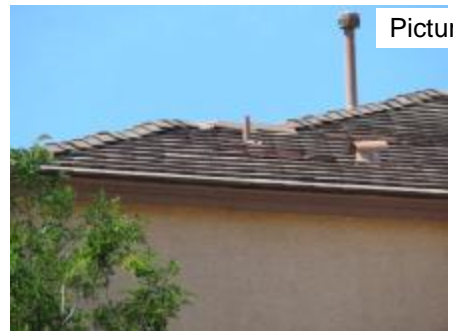
Picture 24

The main roof covering and exposed flashing appears to be in serviceable condition.

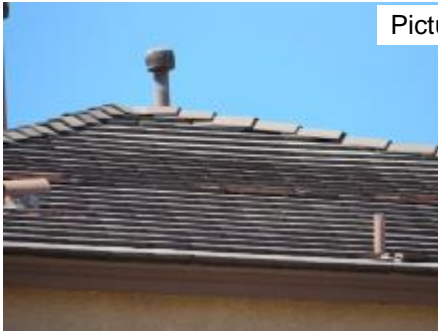
Picture 85

The main roof covering and exposed flashing appears to be in serviceable condition.

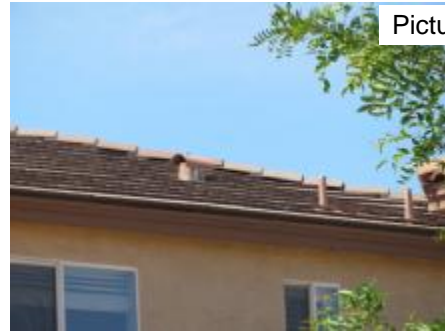
Picture 86

The main roof covering and exposed flashing appears to be in serviceable condition.

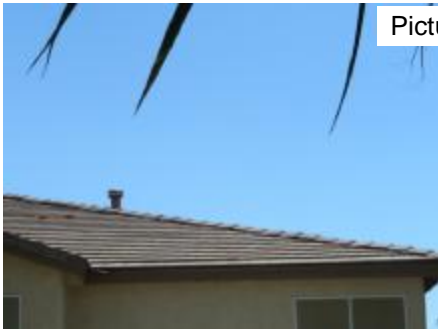
Picture 87

The main roof covering and exposed flashing appears to be in serviceable condition.

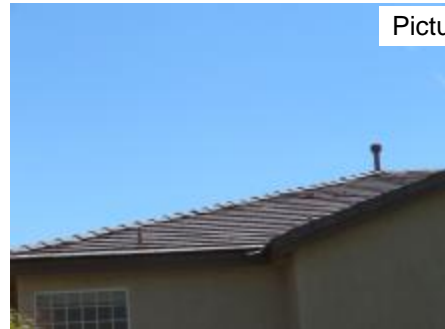
Picture 88

The main roof covering and exposed flashing appears to be in serviceable condition.

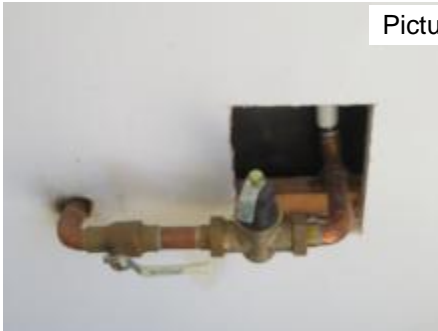
Picture 25

Main water shut off valve and regulator is installed in the garage.

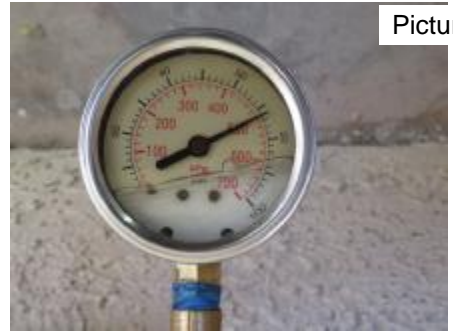
Picture 26

Water pressure was 75 PSI at the time of the inspection.

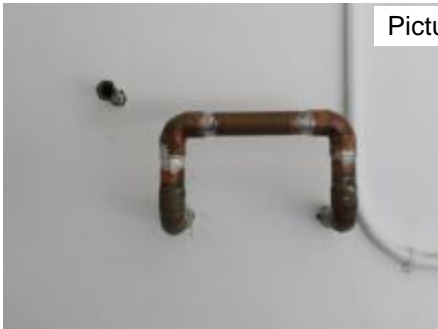
Picture 27

Pre plumbed water softener loop installed in the garage.

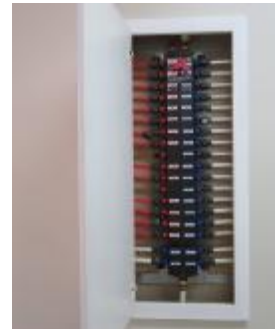
Picture 28

Water system Isolation block is installed in the laundry room appears to be in serviceable condition.

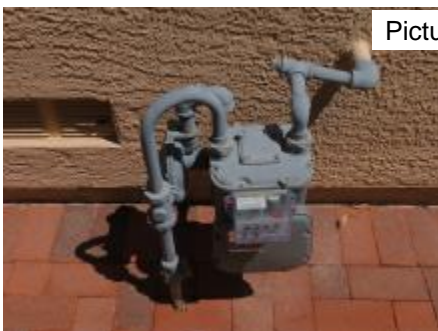
Picture 29

Natural gas system appeared to be in serviceable condition at the time of the inspection.

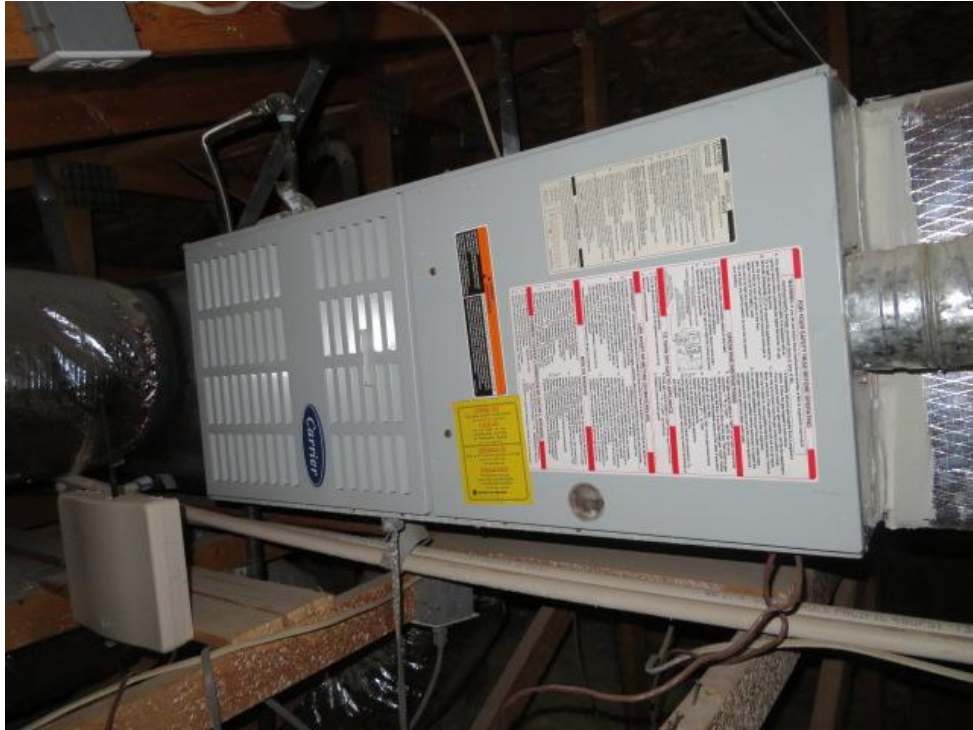
Picture 31

The heating system appeared to be operational at time of inspection.

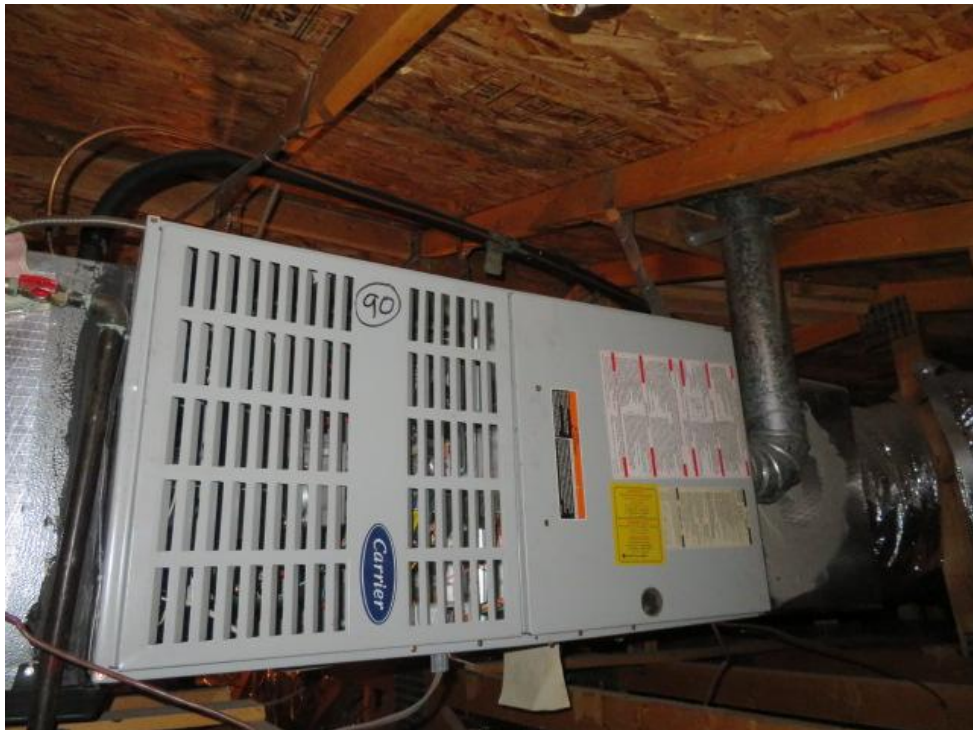
Picture 32

The heating system appeared to be operational at time of inspection.

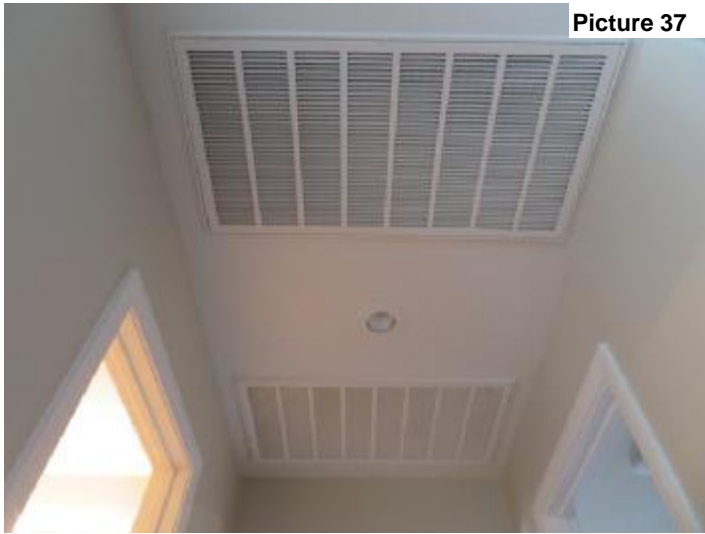
Picture 37

Suggest changing the air filters at the time of the inspection.

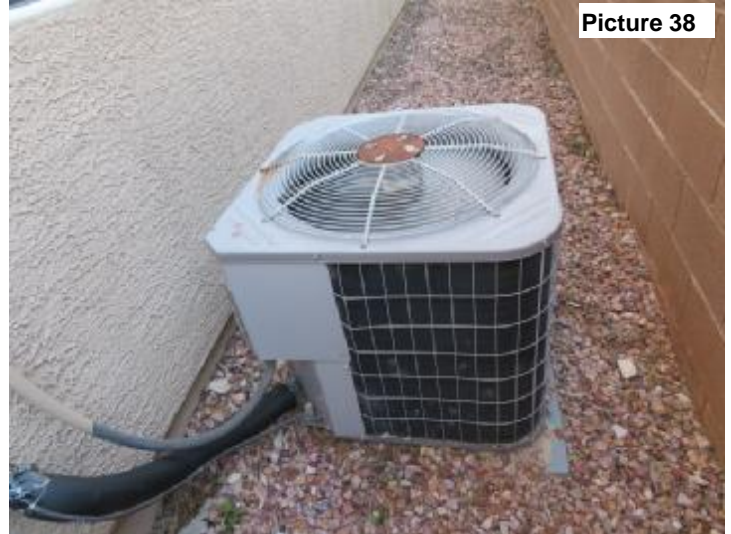
Picture 38

The down stairs cooling system appeared to be operational at the time of the inspection. Recommend servicing the cooling system and checking the refrigerant level annually. (\*)

Recommend servicing the cooling system and checking the refrigerant level annually. (\*)

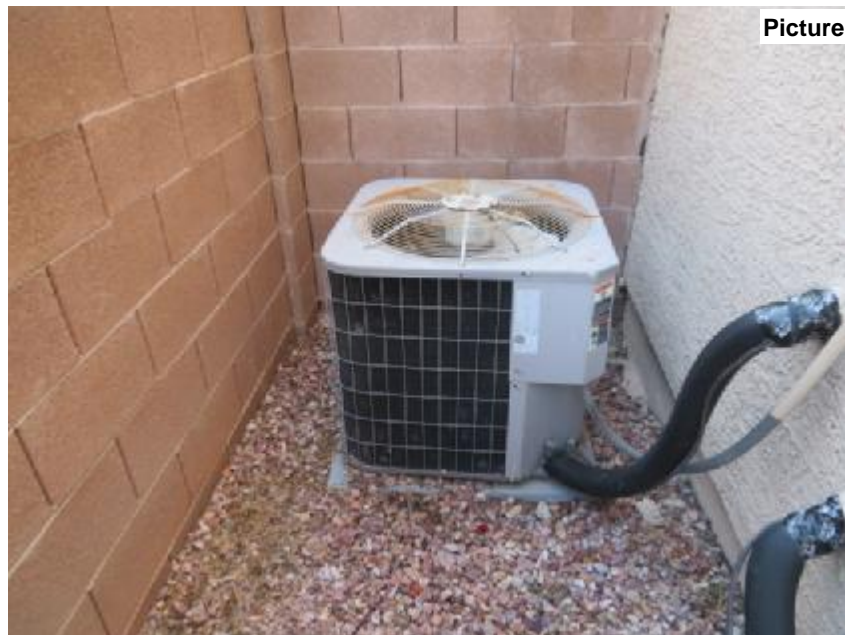
Picture 39

The up cooling system appeared to be operational at the time of the inspection. Recommend servicing the cooling system and checking the refrigerant level annually. (\*)

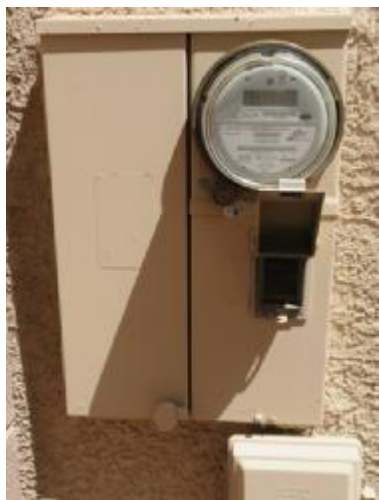
Picture 43

The main panel appeared to be in serviceable condition at the time of the inspection.

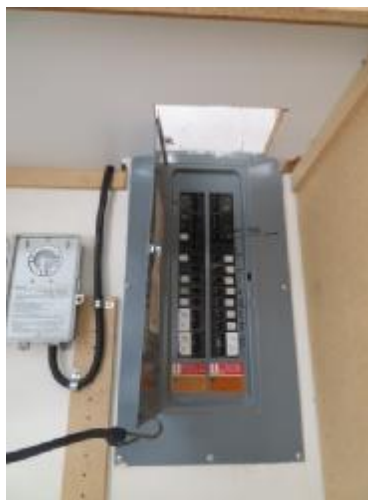
Picture 44

The circuit breaker panel appeared to be in serviceable condition at the time of the inspection.

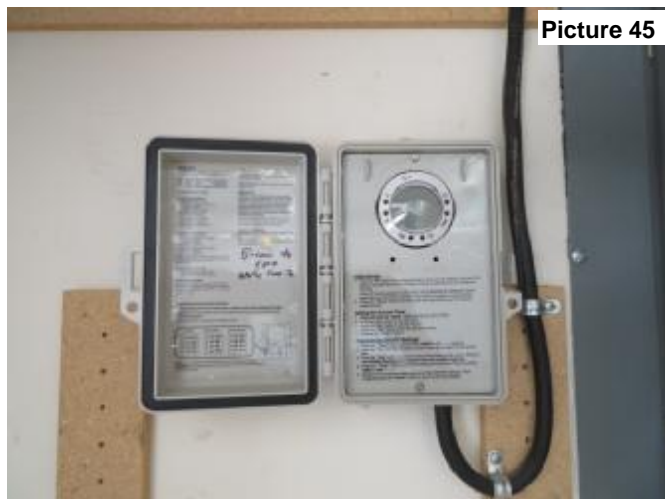
Picture 45

I do not know what this electronic controller is for.

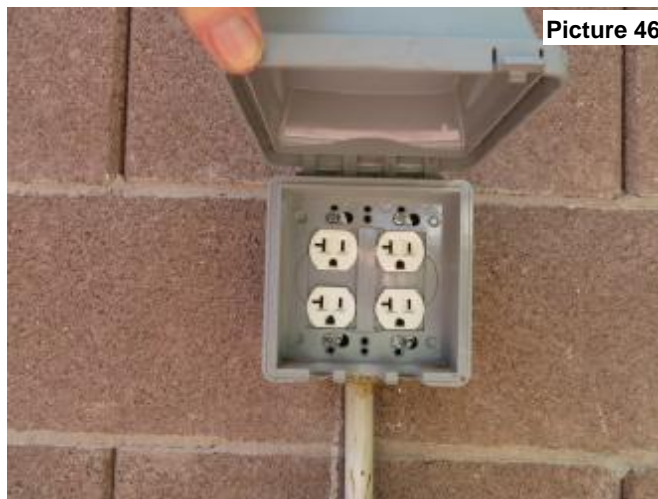
Picture 46

Recommend GFCI protection for the exterior outlets. (2,4)

Recommend GFCI protection for the exterior outlets.

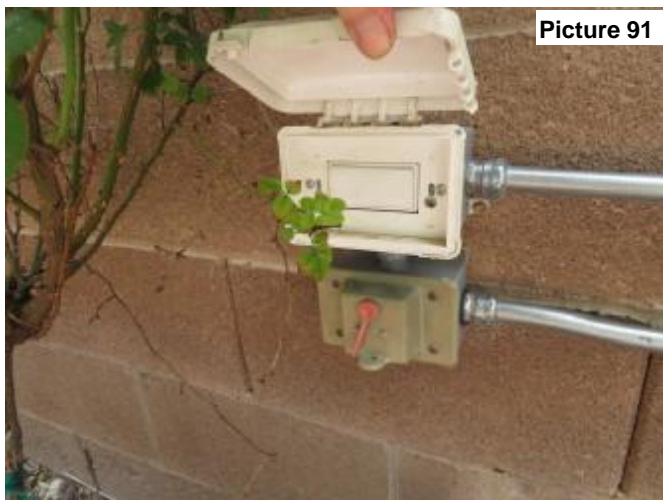
Light switch for the back yard block wall lighting.

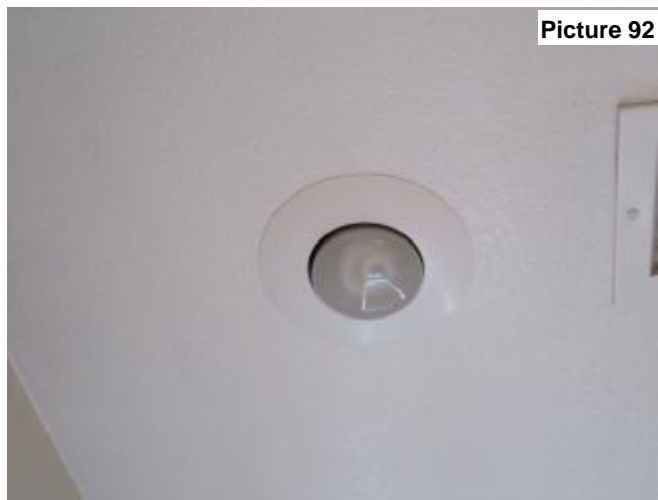
Light bulb in the upper left bathroom is burnt out. (\*)

Light bulb in the upper left bathroom is burnt out.

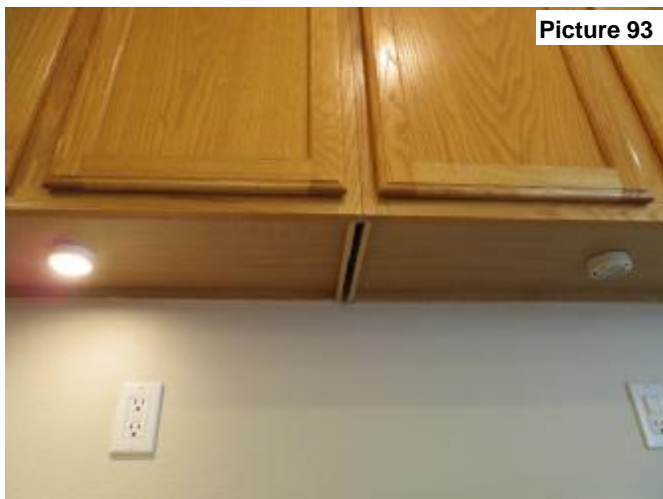
2nd floor desk and kitchen under the counter lighting is missing some of the lights. (\*) One of the lights is not operational.

Kitchen under the counter lighting is missing some of the lights. One of the lights is not operational.

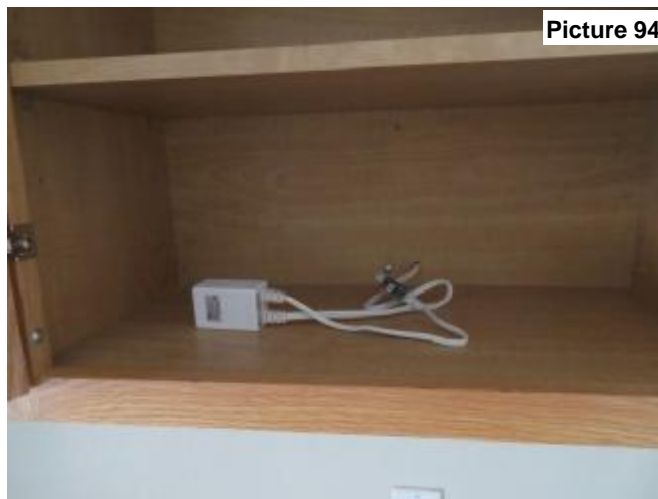
Upstairs desk area under the counter lighting is missing the lights.

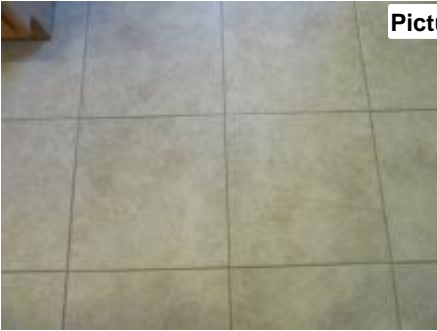
Picture 49

Cracked floor tile's noted in the kitchen area. (\*)

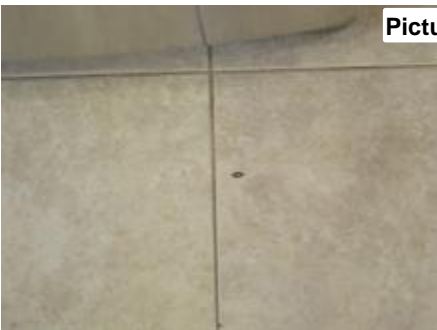
Picture 51

Chipped floor tile's noted in the kitchen area. (\*)

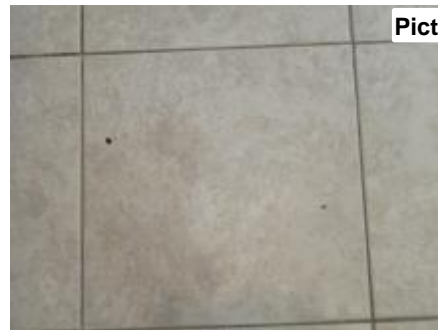
Picture 52

Chipped floor tile's noted in the kitchen area. (\*)

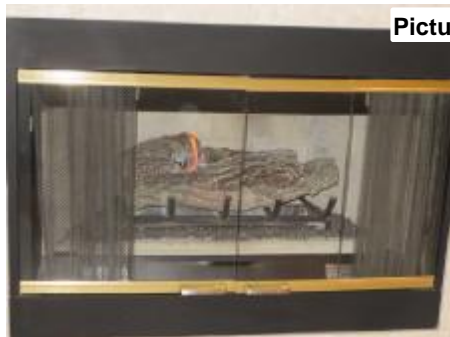
Picture 53

The family room fireplace's appears to be in serviceable condition at the time of the inspection.

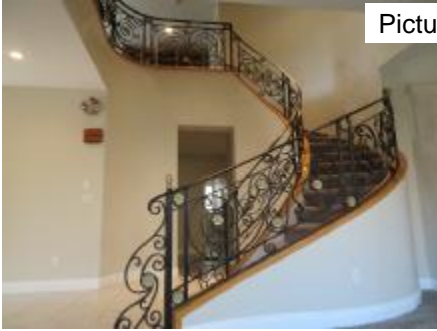
Picture 55

The interior stairs and hand rails appear to be in serviceable conditions.

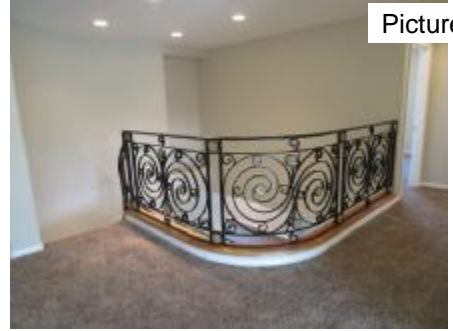
Picture 56

The 2nd floor guard rail appear to be in serviceable conditions.

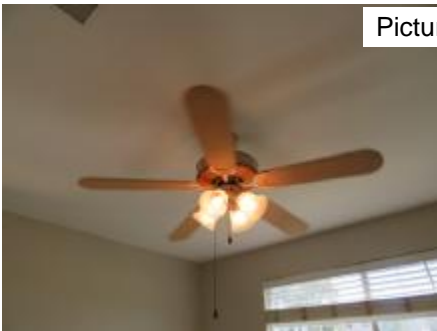
Picture 57

Ceiling fan for the down stairs bedroom wobbles on high speed. (\*)

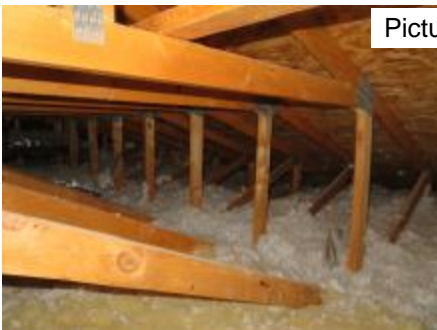
Picture 59

The attic appeared to be in serviceable condition at the time of the inspection.

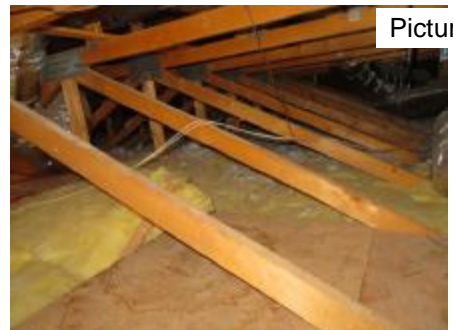
Picture 60

The attic appeared to be in serviceable condition at the time of the inspection.

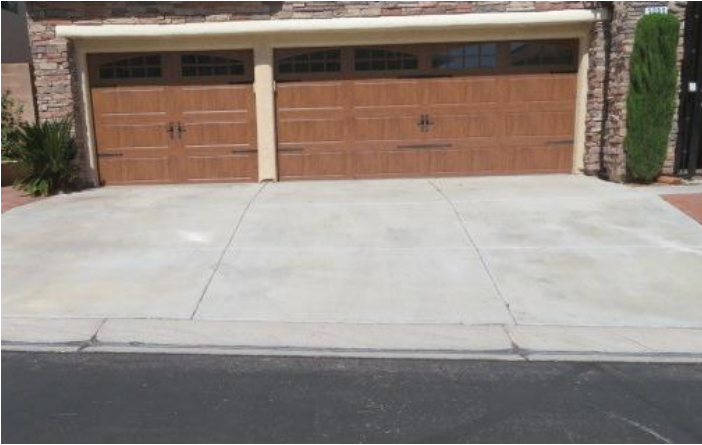
Picture 61

The vehicle door appeared serviceable at the time of the inspection.

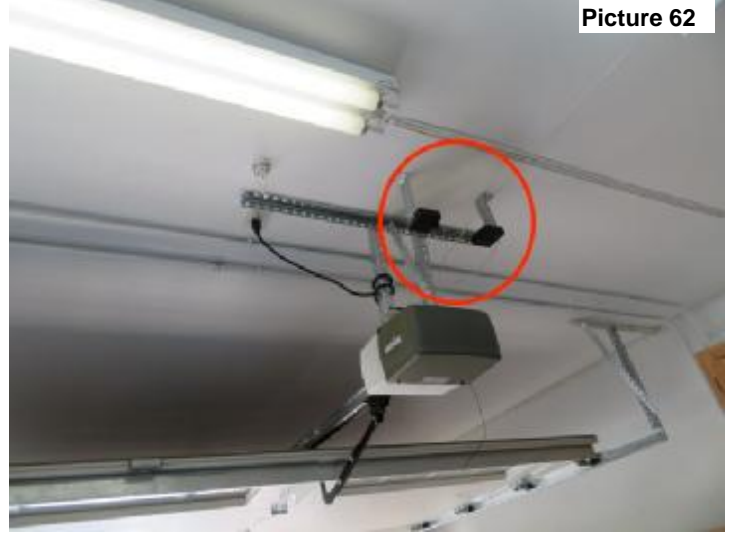
Picture 62

The single door automatic opener appeared operational.

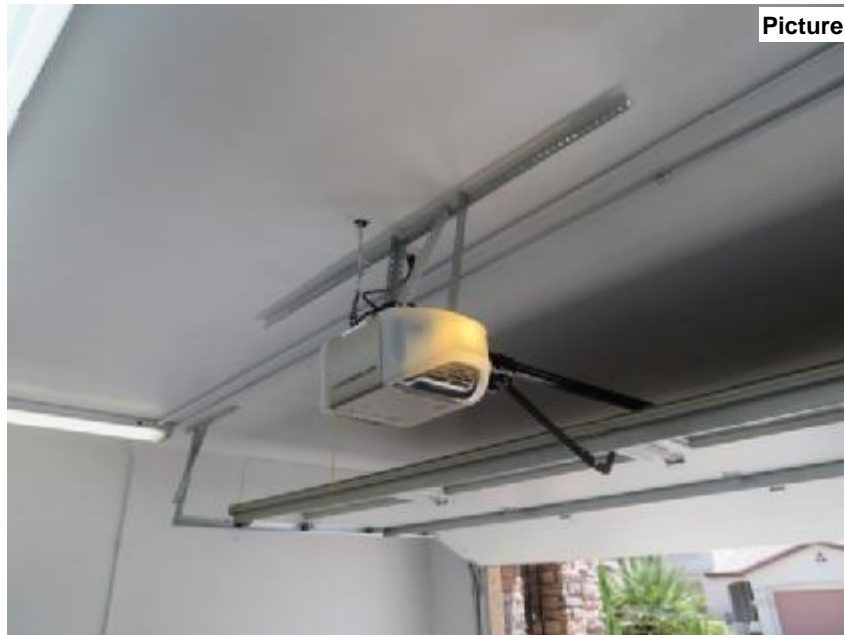
Picture 63

The double door automatic opener appeared operational.

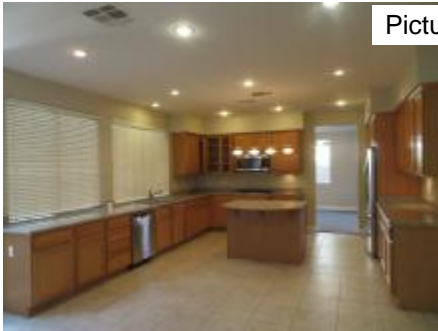
Picture 67

The kitchen cabinets and counter tops appeared to be in serviceable condition at the time of the inspection.

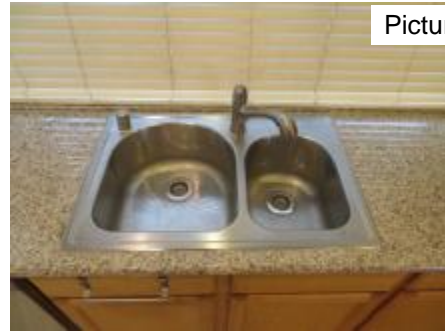
Picture 68

The kitchen sink and faucet appeared to be operational at the time of the inspection.

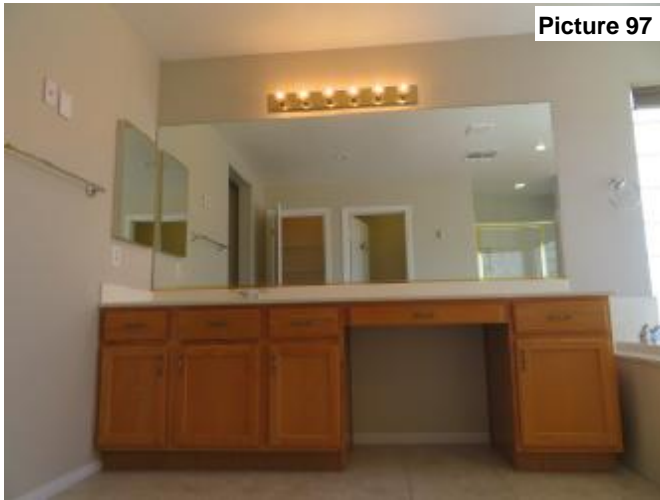
Picture 97

The master bathroom cabinets and sinks appeared to be in serviceable condition.

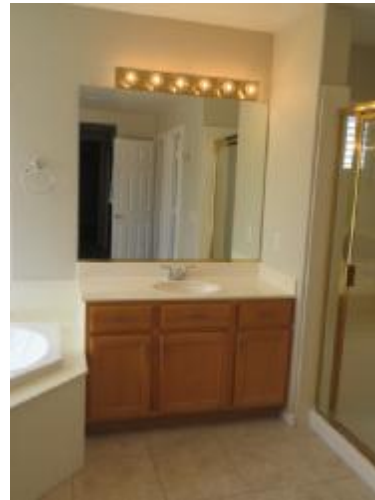
Picture 98

The master bathroom cabinets and sinks appeared to be in serviceable condition.

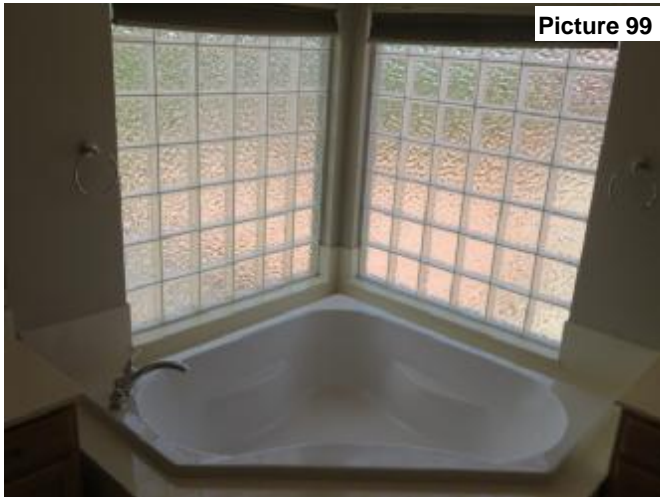
Picture 99

The master bathroom bathtub appeared to be in serviceable condition.

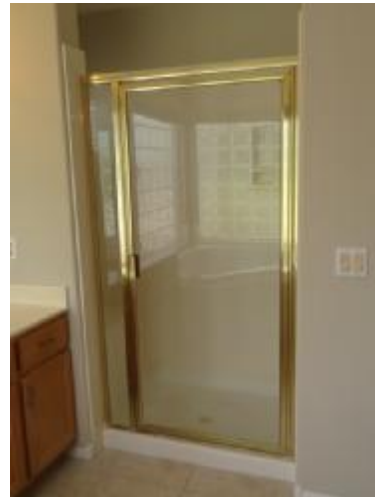
Picture 100

The master bathroom shower enclosure appeared to be in serviceable condition.

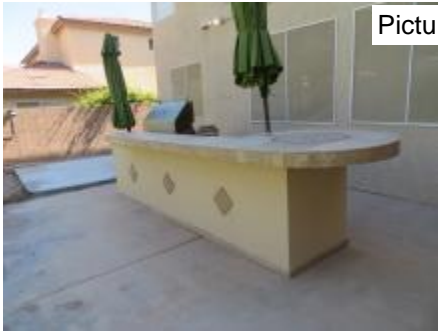
Picture 103

Cosmetic damage noted at the bottom tiles of the patio bar and barbecue.

There are not any propane bottles connected to the barbecue not able to test or operate. Cosmetic damage noted at the bottom tiles of the patio bar and barbecue.

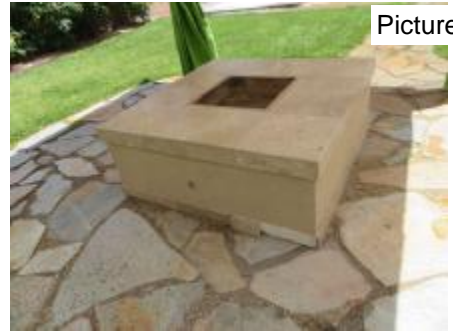
Picture 104

Cosmetic damage noted at the bottom tiles of the fire pit.

There are not any propane bottles connected to the fire pit not able to test or operate. Cosmetic damage noted at the bottom tiles of the fire pit.

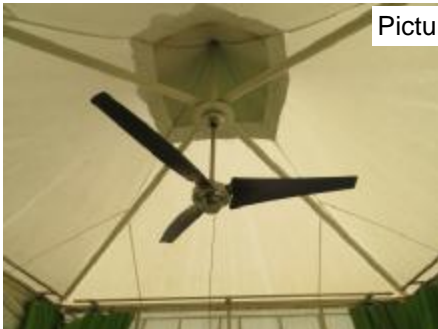
Picture 105

I could not get the gazebo's ceiling fan to operate. Recommend asking where the switch is located?
